**Flood Control Project Maintenance
Levee Inspections**
LMA District Cover Sheet
Spring 2009 Levee Inspection Results

Reclamation District No. 2096

Levee Inspection Report By Mile - Spring 2009

Waterway	Bank	Unit Miles	Inspection Start/End	Inspector
Unit No. 01 San Joaquin River	Right	0.20	05/28/2009 05/28/2009	David Pesavento

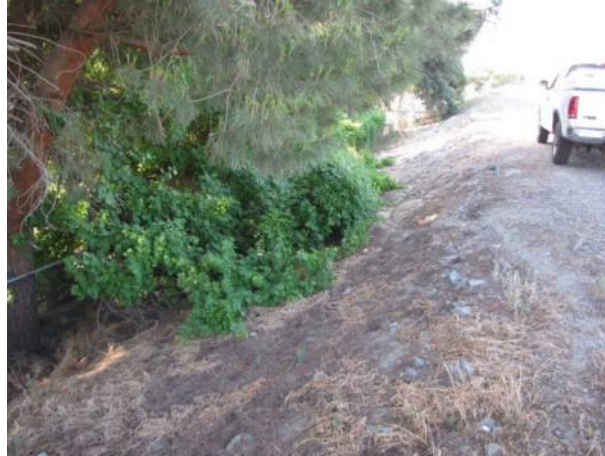
Levee Mile Report Line	2
Start Levee Mile	0.05
End Levee Mile	0.06
Location	Land Side
Category	Earthen Levee
Item	Vegetation

Vines and tree branches on landward side of levee obstructing visibility and access. Remove the vegetation and trim the trees.
